# Summary report for ACT Government

## 2107-ACT-001

Summary Report, Rounds 1 and 2  
Contract Number: EP3222118

The ACT Government engaged PV Lab Australia to test a sample of solar panels on the market in Canberra. This report is a summary of key findings and test results. It is supported by 42 detailed reports, 42 summary reports, a PID report and a technical summary report for each of the two rounds.

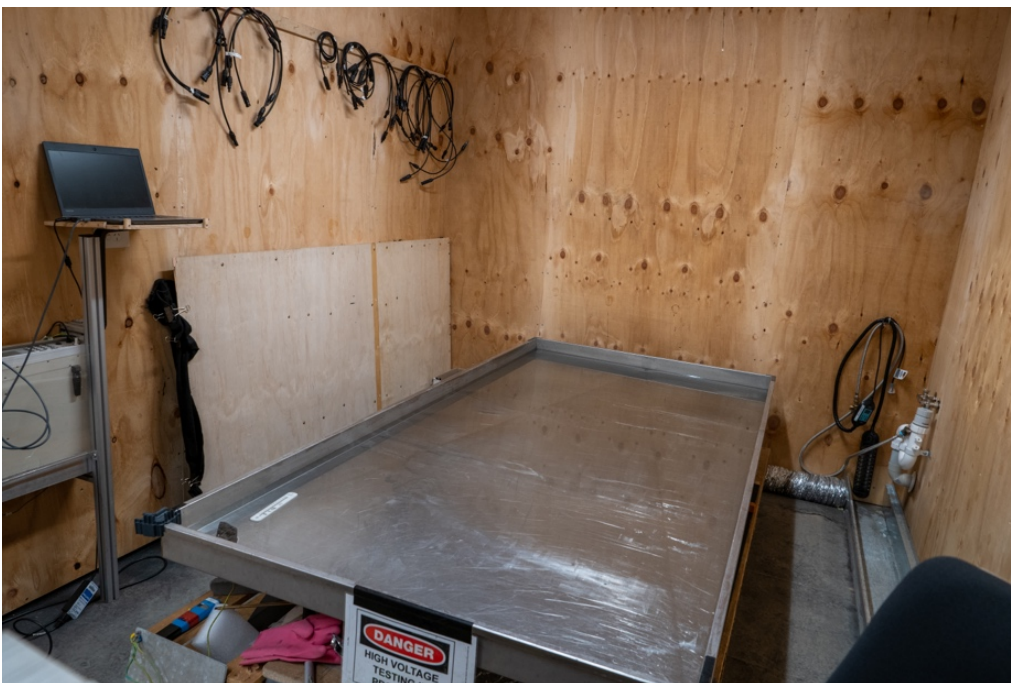
Figure 2: Wet Leakage testing bath at PV Lab

The test is defined in IEC Standard 61215-2 by MQT 15, and measures resistance between the inner circuit of a solar panel and a water bath. For large area solar panels, the measured insulation resistance multiplied by the surface area of the solar panel must be greater than  $40 \text{ M}\Omega \text{ m}^2$ .
